Tree Protection Versus Construction Reality

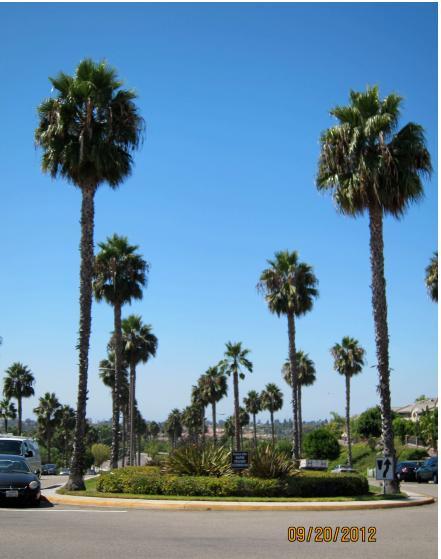
Future high-speed bus lanes to be constructed within existing tree lined medians

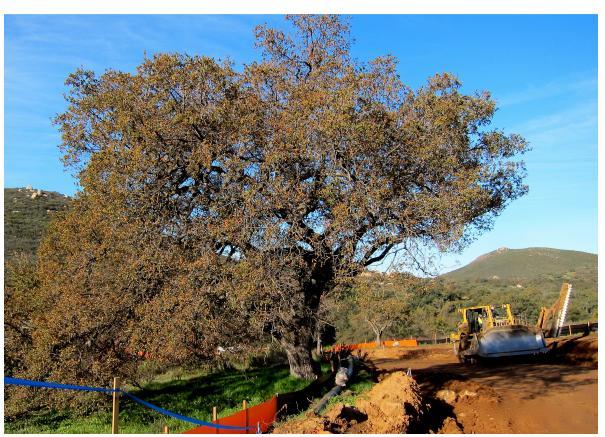
Heavy equipment cuts grade for road, damaging oak tree roots

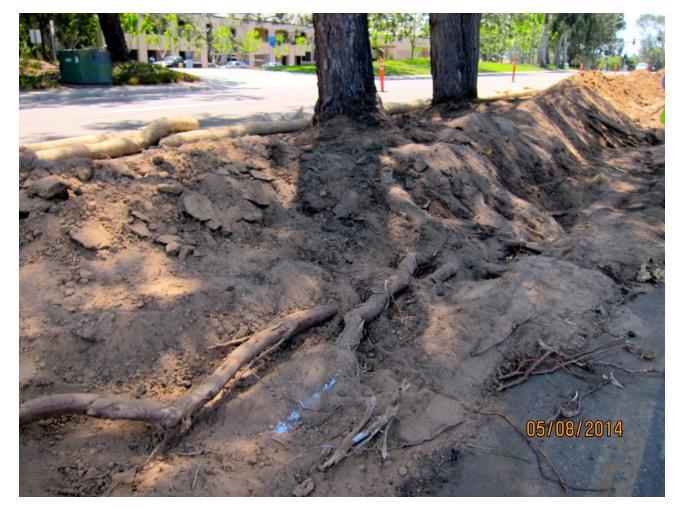
Torrey Pine roots exposed by demolition in the top 12" of soil

Despite numerous warnings, the contractors, inspectors and project manager were quite surprised at the volume and size of tree roots located within the top 12"-24" of soil. Most were under the impression due to tree size and maturity; roots would extend deeply into the soil, like a taproot.

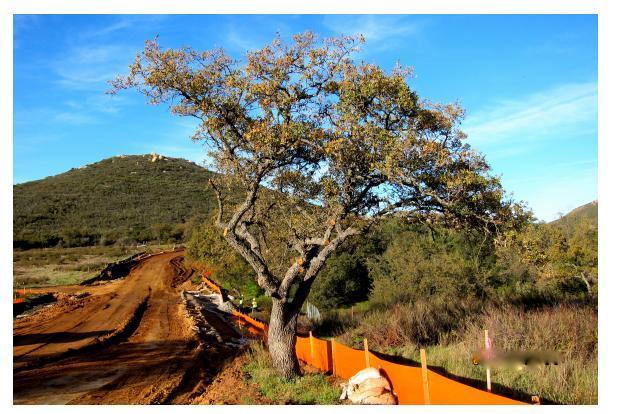
Missing tree protection allowed grader to make road cuts prior to root pruning

This common misconception that trees grow a taproot causes unnecessary root damage. Most tree roots grow within the top 36" of the soil, with upwards of 80% of the tree roots in the top 24" of the soil. The roots grow horizontally toward the dripline of the tree crown and then well beyond the crown of the tree. Therefore, tree root protection should begin at the edge of the tree crown. Believing a tree has a taproot allows construction next to the trunk, causing significant injury to tree roots, trunk and crown.

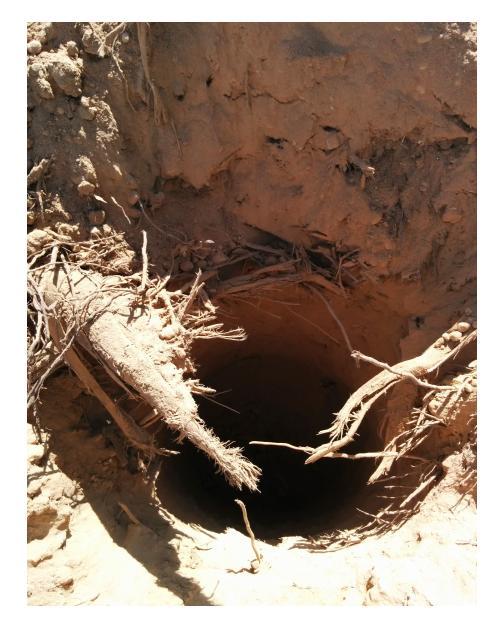
Drilling a post hole without hand excavation

equipment. However, hand excavation is time consuming, many contractors may not understand the importance of locating roots. The picture above is an example of a contractor who began drilling guardrail postholes without first hand excavating. The resultant root damage could have been avoided had the BMP been enforced.

Hand excavation is a best management practice used to locate and expose tree roots to avoid and minimize root damage caused by heavy

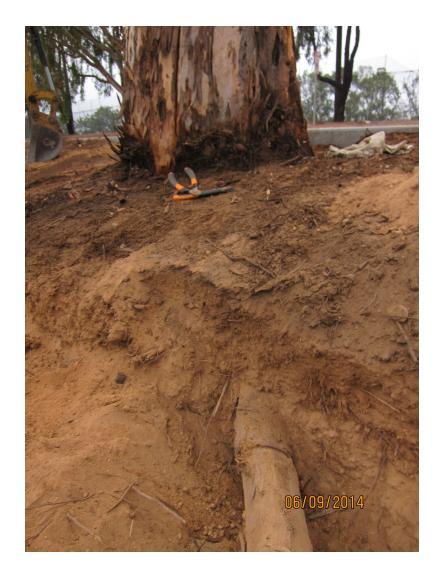
6" structural root located in curb grade

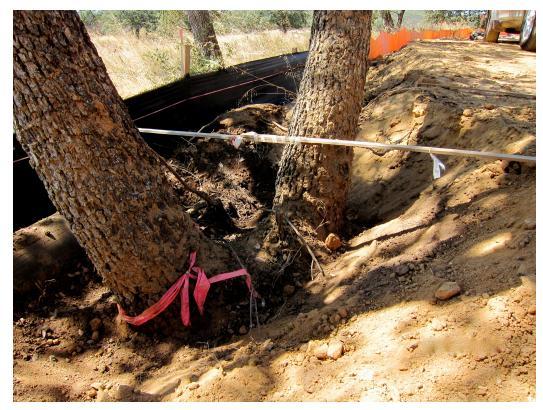
Grading cut and fill operations are problematic when existing trees are on the very edge of the work alignment. Placing fill soil on top of roots effectively suffocates and kills the root system while cuts under the tree crown invariably cause root damage

Fill covered 18" of the tree trunk later exposed

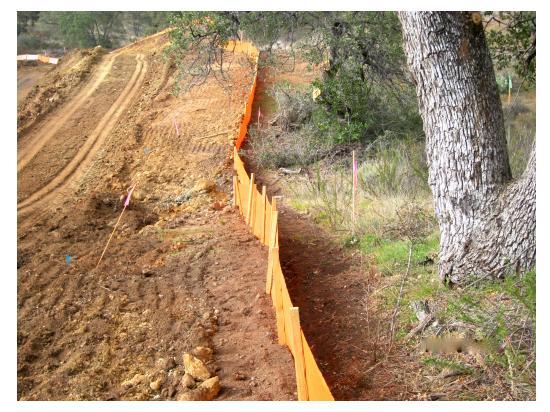
Grading cuts damaging native oak tree roots

Sometimes, you can only do so much for an "edge" condition tree. Their location is in such close proximity to the workspace, no matter how much crown and root pruning is performed, the tree is going to suffer significant construction impact. In these instances, trying to minimize the damage is most likely the most that can be accomplished.

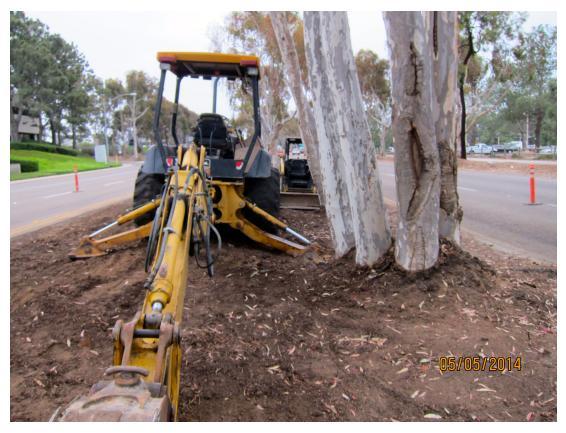
Equipment is frequently parked under trees

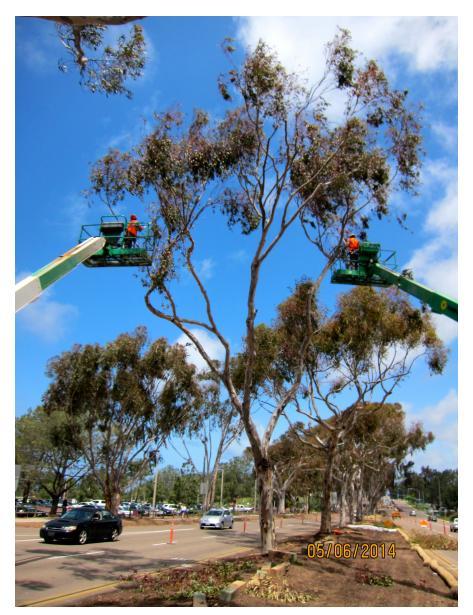
Preconstruction crown pruning to compensate for expected root loss

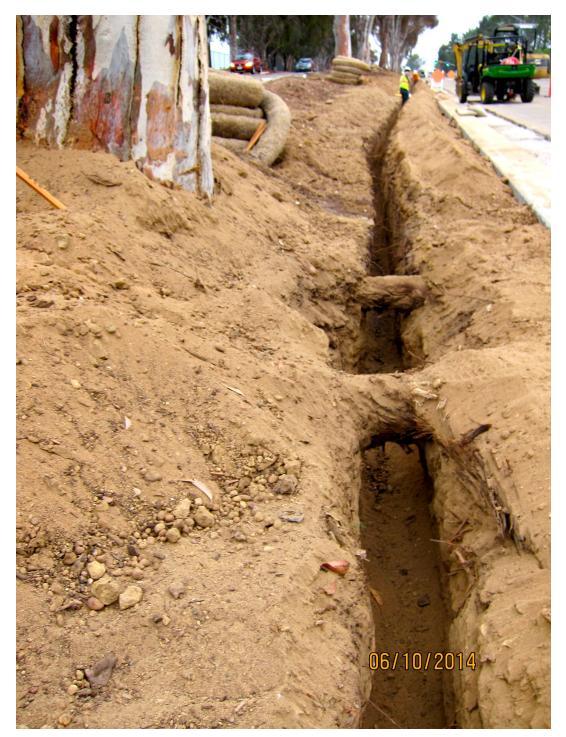
Trenching under rather than through roots is a good thing!

By teaming with the general contractor, I have been successful in getting them to "buy" into the tree protection program. Once that buy in has occurred, implementation and compliance run much more smoothly and effectively. The picture on the left shows how the contractor decided to tunnel under large structural roots to install irrigation mainlines. At the start of the project, the contractor was inadvertently damaging these kinds of roots. I worked with the supervisor explaining the importance of root protection and over time, he really began to take the protection program to heart. It was his suggestion that they tunnel under the roots to install mainline.

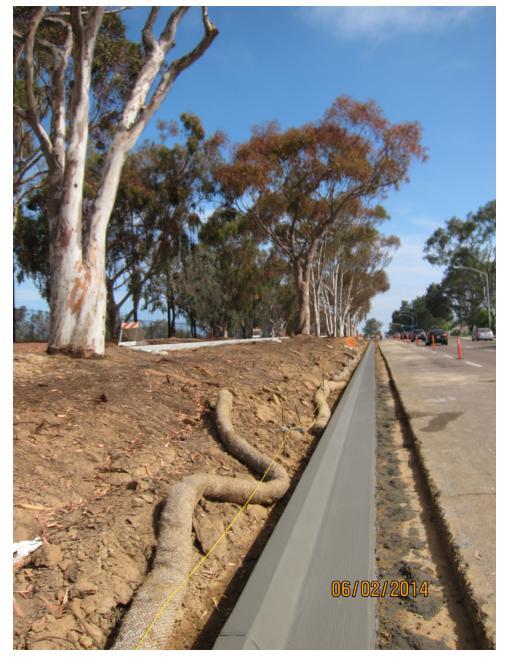
Curb and gutter is installed, will the trees survive? Only time will tell.
